LANDSLIDES IN ARMENIA¹

VLADIMIR BOYNAGRYAN*

Key words: Armenia, landslides, Ahardzin.

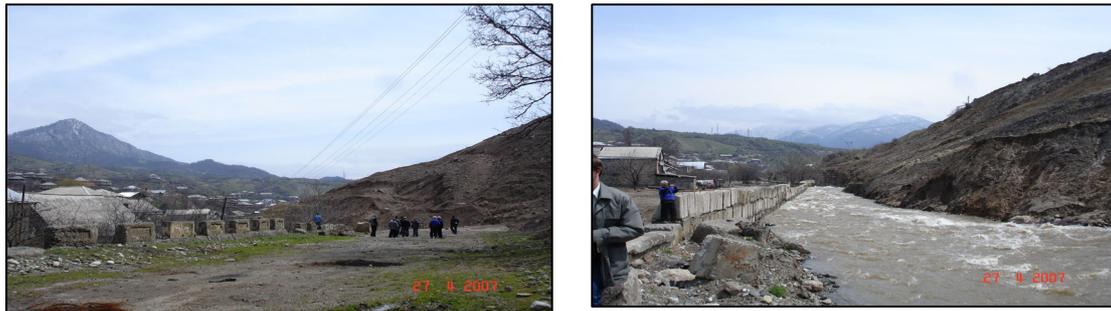
Fig. 9 – Motorway blocked by landslide (a) and landslide masses fallen into the River Aghstev bed (b).

The permanent road was fully destroyed, the motorway was broken and on April 3, 2001 75% of the River Aghstev bed was barred. Liquidation of such an extraordinary situation (Fig. 9) proved to be very costly.

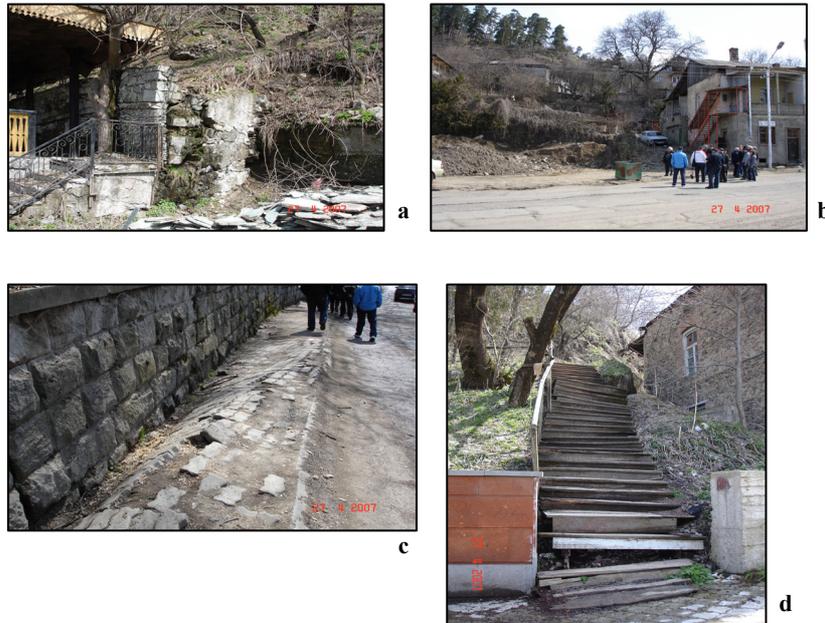
Fig. 11 – The consequences of displaced landslide masses in the town of Dilijan: *a, b*, landslide masses fall on streets and buildings; *c*, strained cover of street; *d*, strained stone stairs.

The displacement of the Dilijan landslides was activated after the 1988 Spitak earthquake and especially after the collapse of the USSR, when financing of antilandslide actions ceased. As a result, the territory of Dilijan is now in a very deplorable condition (Fig. 11).
